Report No. CG-WEP-2-79

FATE OF OIL SPILLED FROM THE  
SUPERTANKER METULA

JANUARY 1979

FINAL REPORT

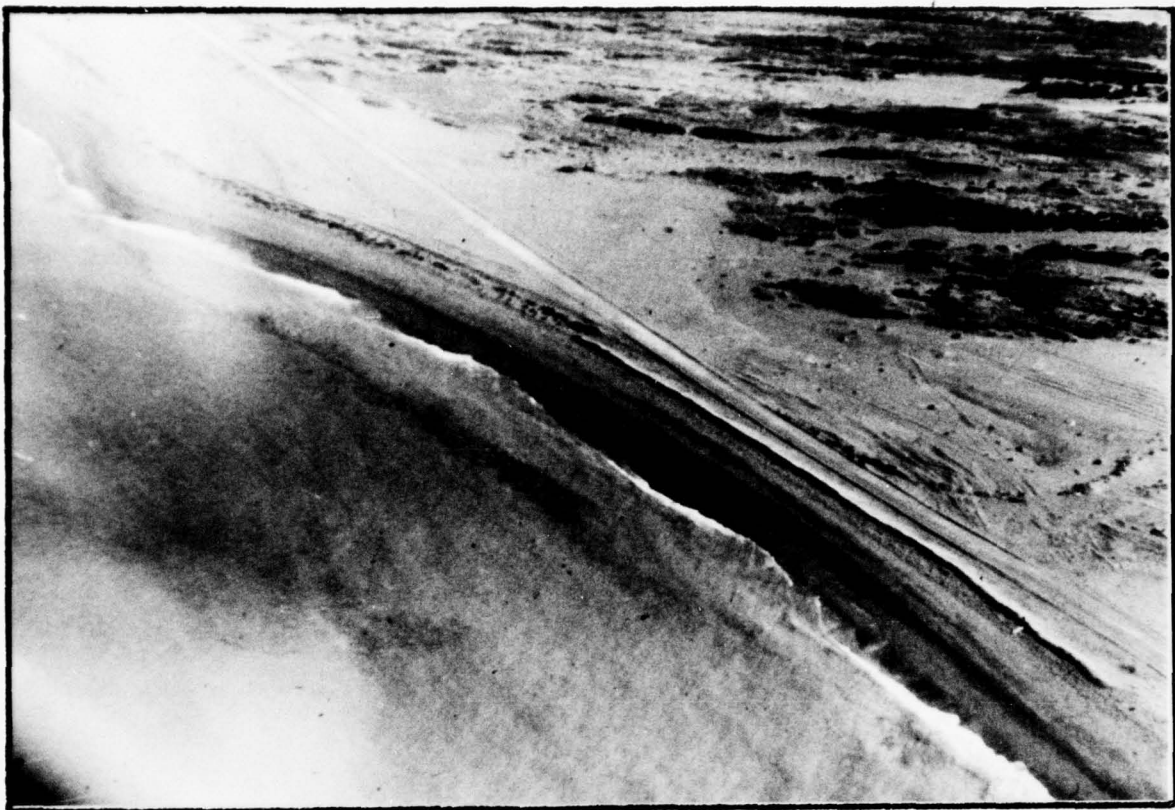
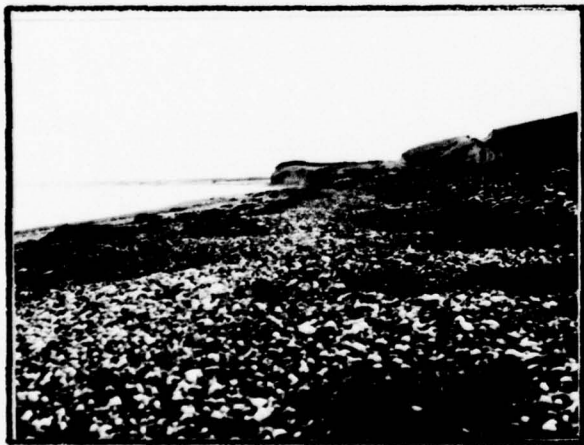
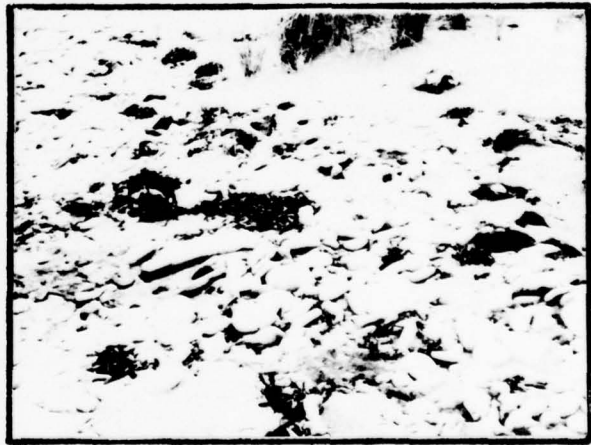
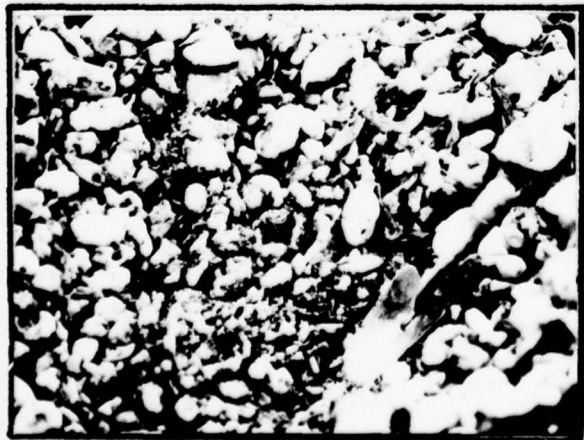
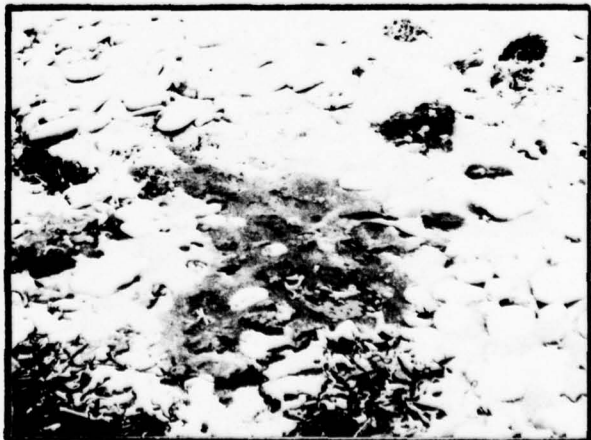
FIGURE 38

The deposits on this shore remained in the normal high tide area rather than being blown higher and inland as on Bahia Felipe. Figure 37 Parts B and C show views of this area in 1975.

In 1978 extensive oiling was found on this shore near an ENAP sludge spill point and near Punta Dungenes where a recent ENAP oil spill took

place. Figure 38 Parts D and E show examples of these later spills. No oil was found, however, that appeared to be METULA oil. It is believed the location of these beaches so as to receive heavy surf from the strong westerly winds caused the oil to quickly dissipate into the water column.

- A - Stranded mousse at top of beach east of Punta Posession.
- B - View of oil spotted rocks on the beach east of Punta Posession.
- C - Closeup of oiled area on beach east of Punta Posession.
- D - Oil patches of questionable origin east of Punta Posession.
- E - New oil from non-METULA source near Punta Dungenese.

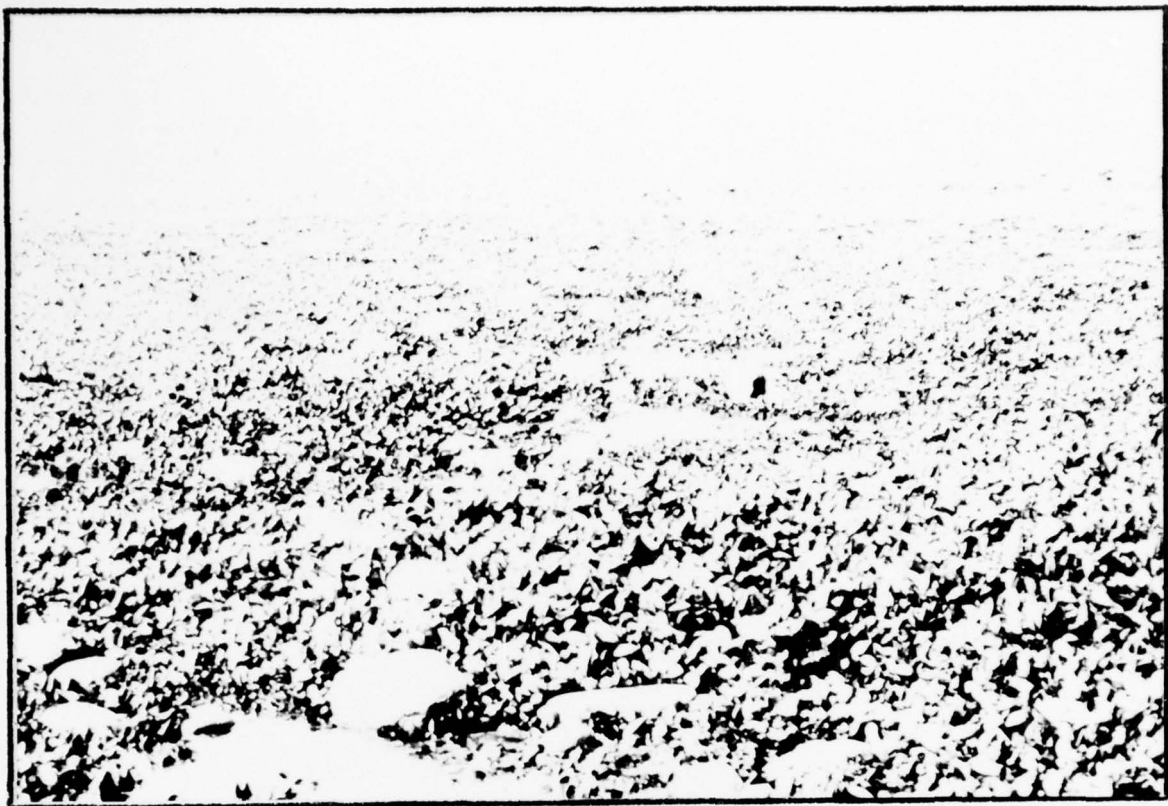
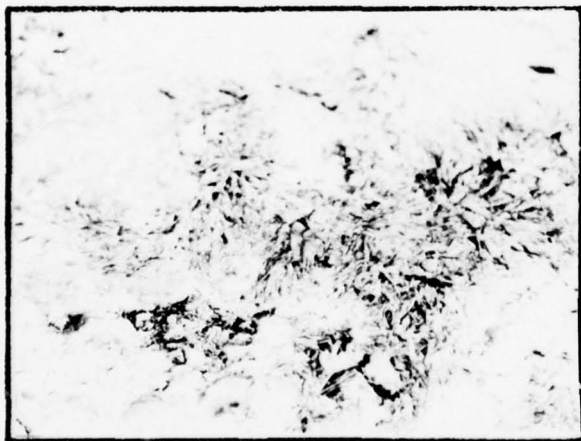
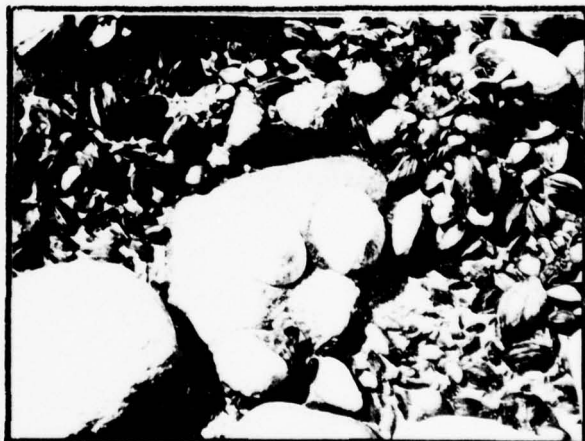
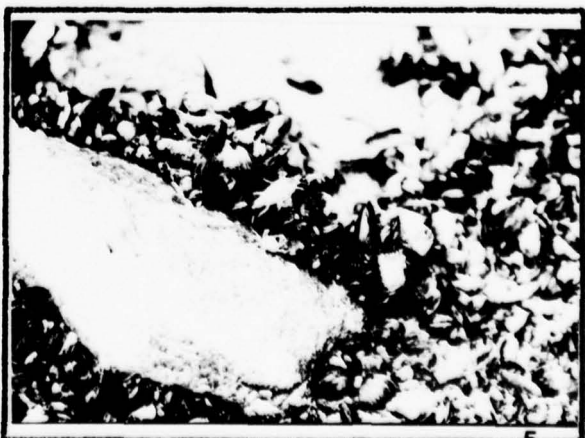
FIGURE 39

In the spill area there was a definite lack of crustacea when compared to the control area. There also appeared to be a decrease in limpets on the impacted coast, but a modest algal bloom appears to have triggered a strong comeback. The mussel community was undoubtedly affected, but live mussels were observed in areas where they were completely surrounded by mousse. A washed-out looking algae has even thrived on the surface of the moussecrete areas.

- A - Dense mussel colony on the southeast arc of Bahia Felipe.
- B - Algae growing on oiled sediment.
- C - Large mussel colony on rock in lower Intertidal Zone.
- D - Limpets and mussels.
- E - Initial sign of crustacea on south shore of Narrows.

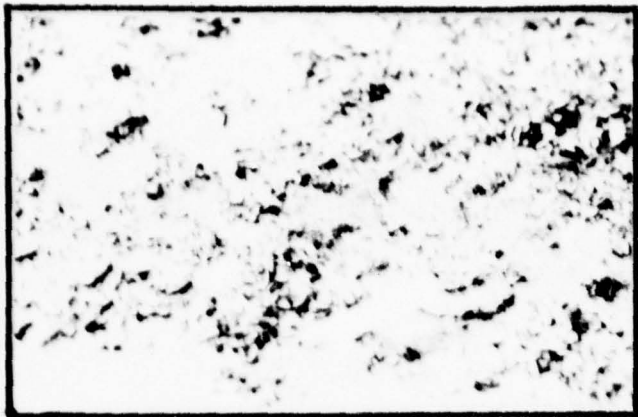
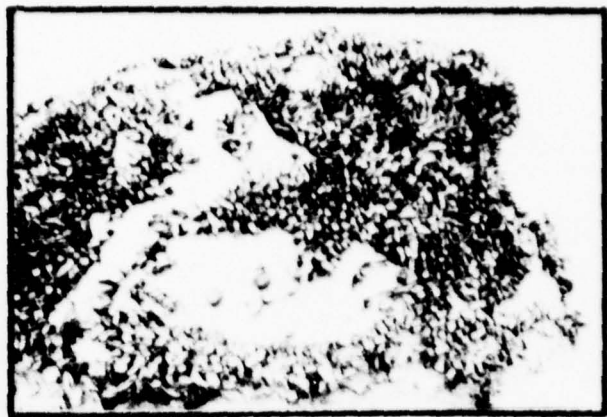
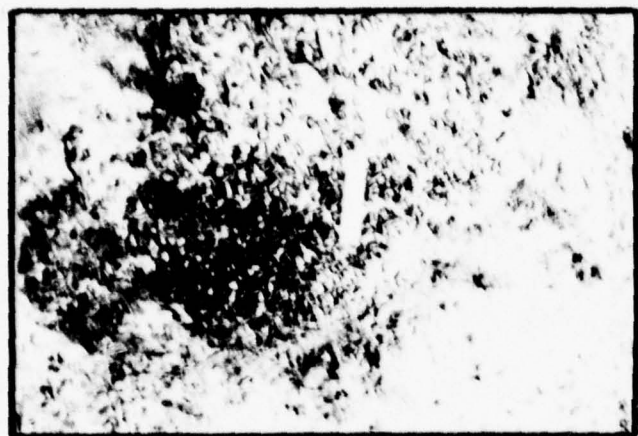
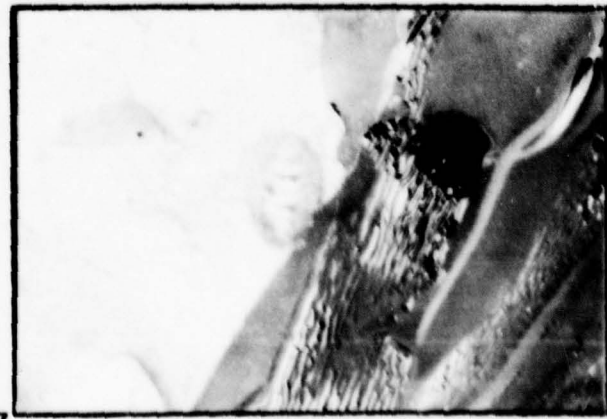
FIGURE 40

- A - Mussels paved with mousse in Espora area.
- B - Mussel community in lower intertidal zone Espora area.
- C - Starfish impacted by oil on Espora Flat.
- D - Group of organisms collected from freshly beached kelp.
- E - Dense mussel bed in lower Intertidal Zone at Bahia Felipe.
- F - Blooming limpet population on south shore of Bahia Felipe.
- G - Organisms laying eggs on Punta Baxa area of Bahia Felipe shore.
- H -

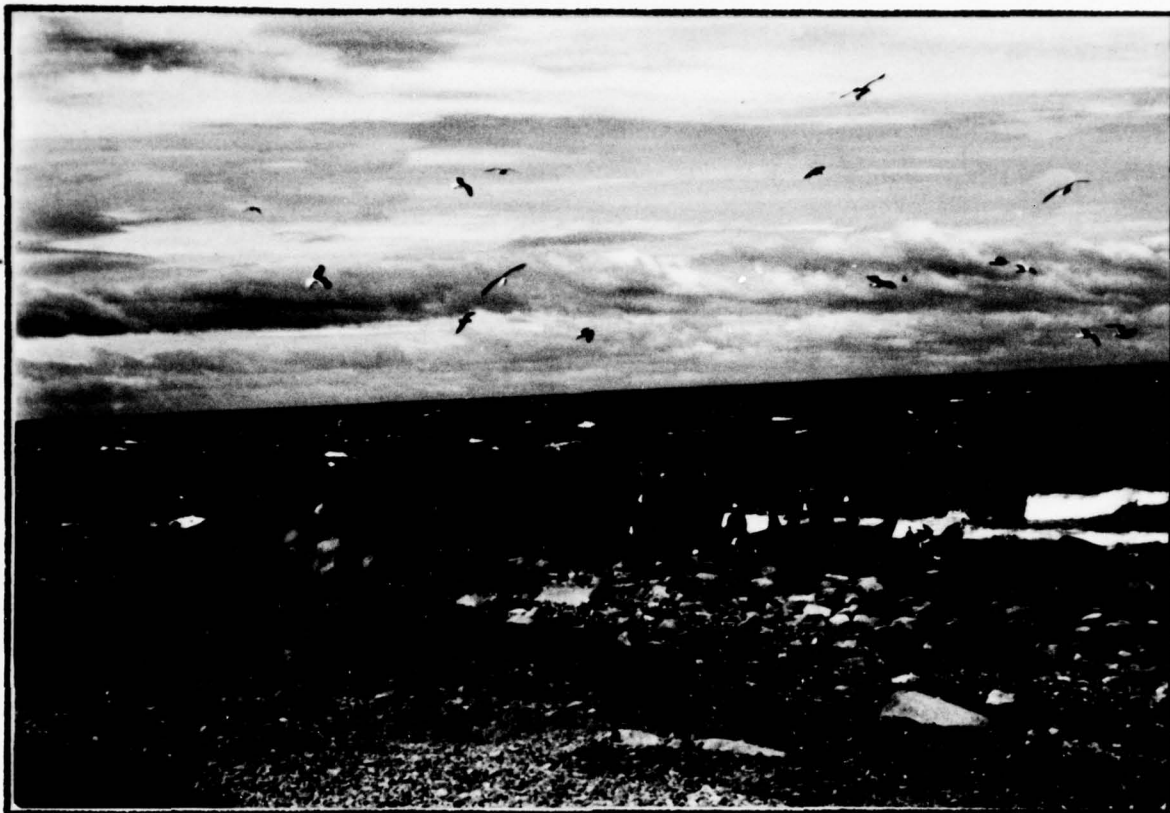
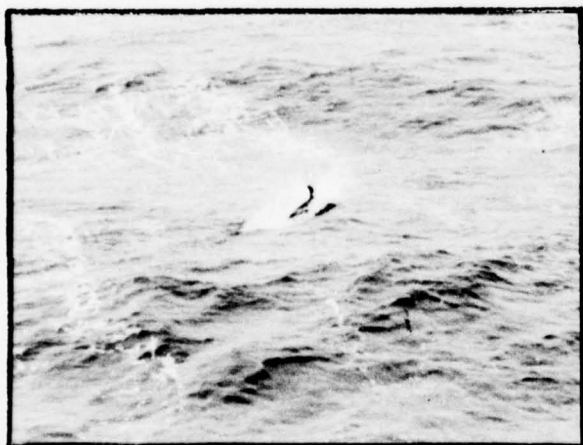
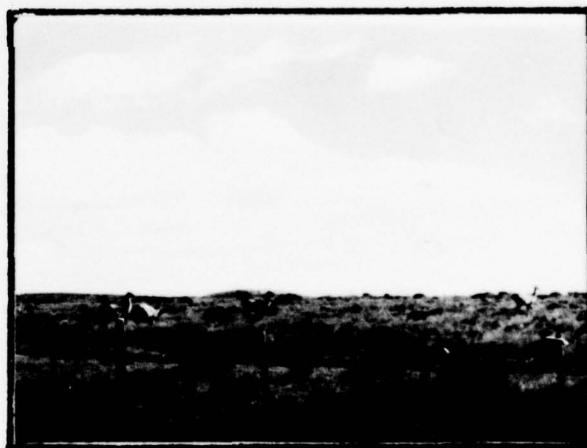
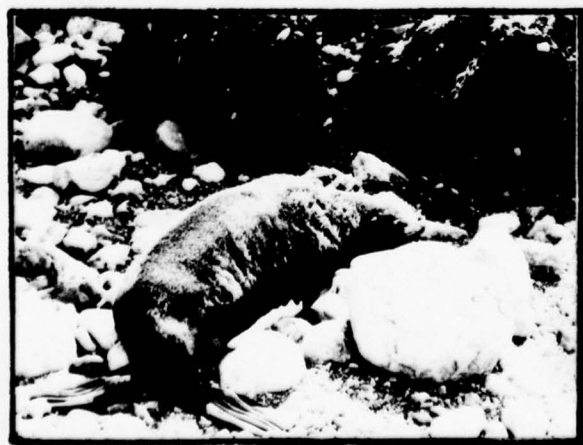
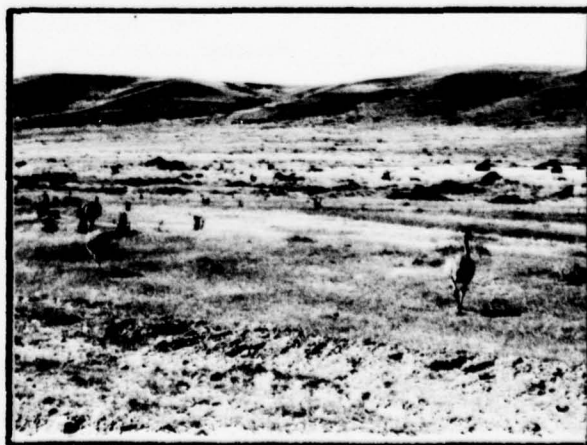
**FIGURE 41**

Marine mammals are represented in Figure 41 by porpoises which chase the ferries across the Narrows and the sea lion community on Isla Magdalena in the middle of the Straits.

- A - Sea Lion community on Isla Magdalena in the Strait of Magellan.
- B - Porpoise in Ferry Wake.
- C - Close-up of Sea Lion, Isla Magdalena.
- D - Guanaco's near beach on Tierra del Fuego.
- E - Ria's near beach road near Punta Posession.

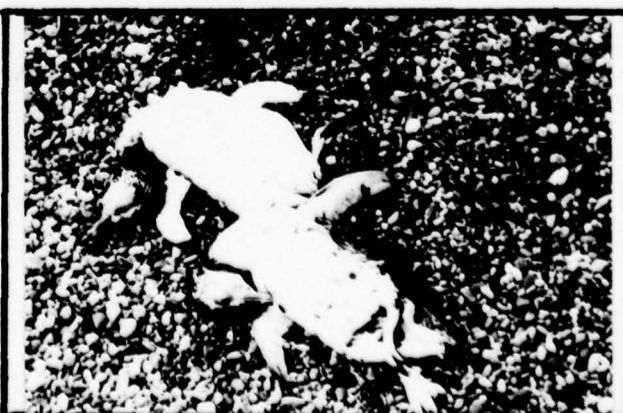
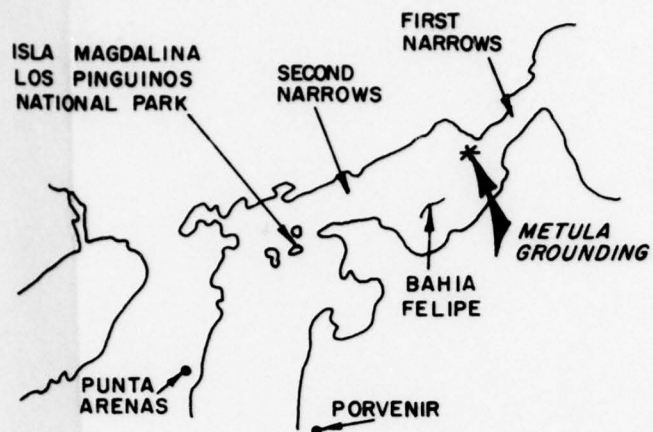
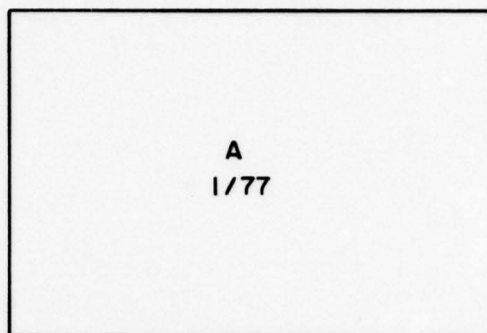
FIGURE 42

The significant impact of the spill on waterfowl was reported in detail in the initial METULA report by the author. The greatest impact was on the cormorant and penguin communities. Figure 42 Parts A through D show oiled and dead cormorants and penguins at the time of the spill and in January 1975. Mummified oiled birds could still be seen in 1978 as shown in Part E of Figure 42.

- A - Oiled Cormorant near Punta Espora.
- B - Group of 22 dead cormorants found within a 15 meter radius east of Punta Anegada.
- C - Oiled dead Penguin.
- D - Oiled Penguin.
- E - Oiled dead Penguin.
- F - Oiled dead Penguins near Punta Dungenes.
- G - Penguins trapped in fish nets near Punta Dungenes.
- H - Close-up of oiled dead Penguins killed in nets.
